## ***PARKLANE GARDENS - STAGE 2***

Level One Report

P210917-16897

**RE: Parklane Gardens - Stage 2  
Level 1 Compaction Control**

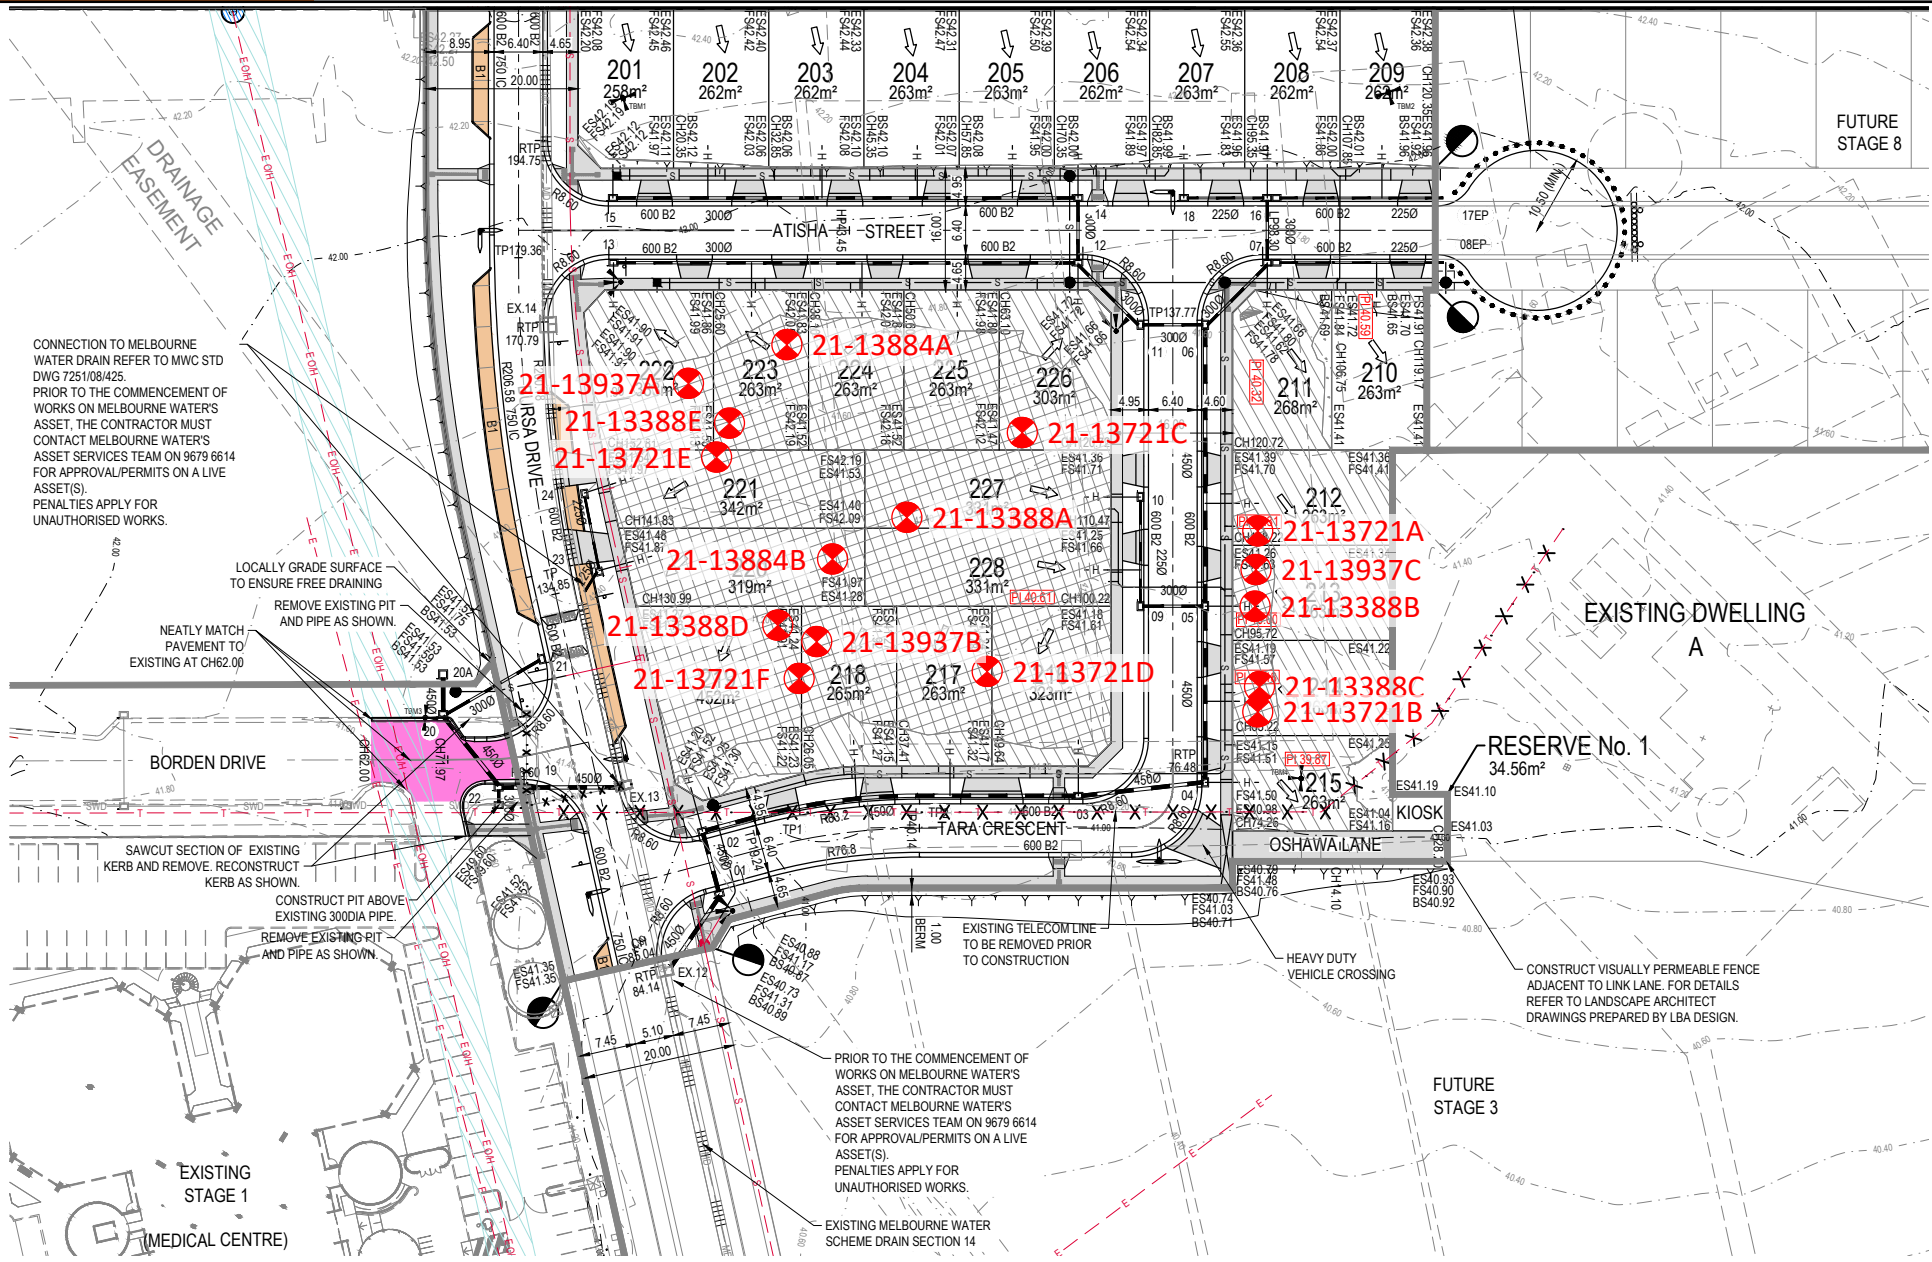
Initial site inspection showed one fill area as per the attached site plan. This area was consecutively stripped of all deleterious silty topsoil, organic matter and existing fill down to a silty Clay. The area was then compacted with a smooth drum roller and proof rolled with a loaded dump truck. No deflection was sited.
